TEST REPORT

Project No: 3058840

Class: Class Series 2000, Class 2017, Automatic Sprinklers, Non-Storage, Pendent

Product Name: Model 2013 KT, 2014 SHKT and 2015 SHKT with a Nominal Discharge Coefficient of 5.6 gal/min/(psi)^{1/2} [80.7 L/min/bar^{1/2}] in Chrome Finish, with a Nominal Temperature Rating of 155°F (68°C) (F5 Job Bulbs)

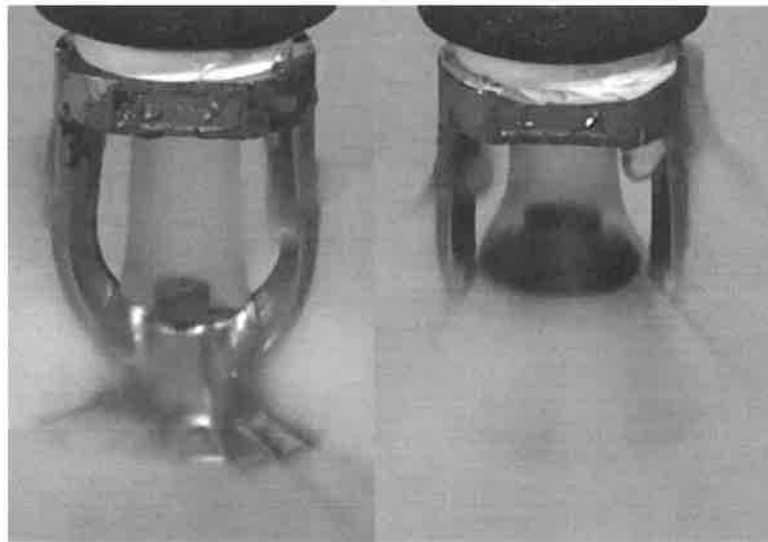
2013 KT Automatic Sprinkler at 7 psi

Eighty samples (“2013 KT”) total were installed in their intended orientation on a water supply line. Five samples at each water pressure of 7, 25, 50, 75, 100, 125, 150 and 175 psi (0.5, 1.7, 3.4, 5.2, 6.9, 8.6, 10.3 and 12.1 bar) were tested utilizing a double feed piping arrangement. Five samples at each water pressure of 7, 25, 50, 75, 100, 125, 150 and 175 psi (0.5, 1.7, 3.4, 5.2, 6.9, 8.6, 10.3 and 12.1 bar) were tested utilizing a single feed piping arrangement. The samples were each activated using a suitable heat source and observed. The results are shown in Table 1. The cumulative lodgment rate for the forty samples tested in the double feed piping configuration was 47.5% (19/40). The cumulative lodgment rate for the forty samples tested in the single feed piping configuration was 37.5% (15/40). The cumulative lodgment rate for all eighty samples tested was 42.5% (34/80). In order to fulfill the requirements of the standard listed in Section 1.3, the cumulative lodgment rate cannot exceed 1%. It should be noted that the cumulative lodgment rate at 150 psi [10.3 bar] was 80% (8/10) with 100% of the samples tested on the double pipe configuration at 150 psi [10.3 bar] resulting in a lodgment. Similarly, the cumulative lodgment rate at 175 psi [12.1 bar] was 80% (8/10) with 100% of the samples tested on the single pipe configuration at 175 psi [12.1 bar] resulting in a lodgment.

The results were deemed not to meet the requirements of the standard listed in Section 1.3.

No Lodgment

Lodgment

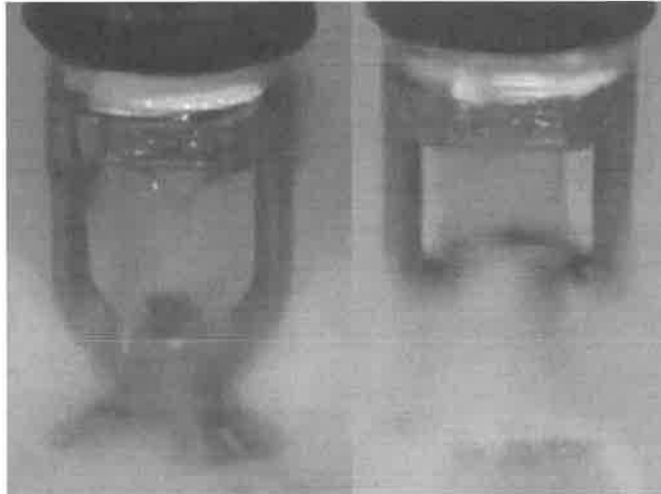
2014 SHKT Automatic Sprinkler at 75 psi

Fifteen samples total ("2014 SHKT") were installed in their intended orientation on a water supply line. Five samples at each water pressure of 7, 75 and 175 psi (0.5, 5.2 and 12.1 bar) were tested utilizing a double feed piping arrangement. The samples were each activated using a suitable heat source and observed. The results are shown in Table 2. The cumulative lodgment rate for the samples was 46.7% (7/15). In order to fulfill the requirements of the standard listed in Section 1.3, the cumulative lodgment rate cannot exceed 1%. It should be noted that the lodgment rate at 175 psi [12.1 bar] was 100% (5/5).

The results were deemed not to meet the requirements of the standard listed in Section 1.3.

No Lodgment

Lodgment

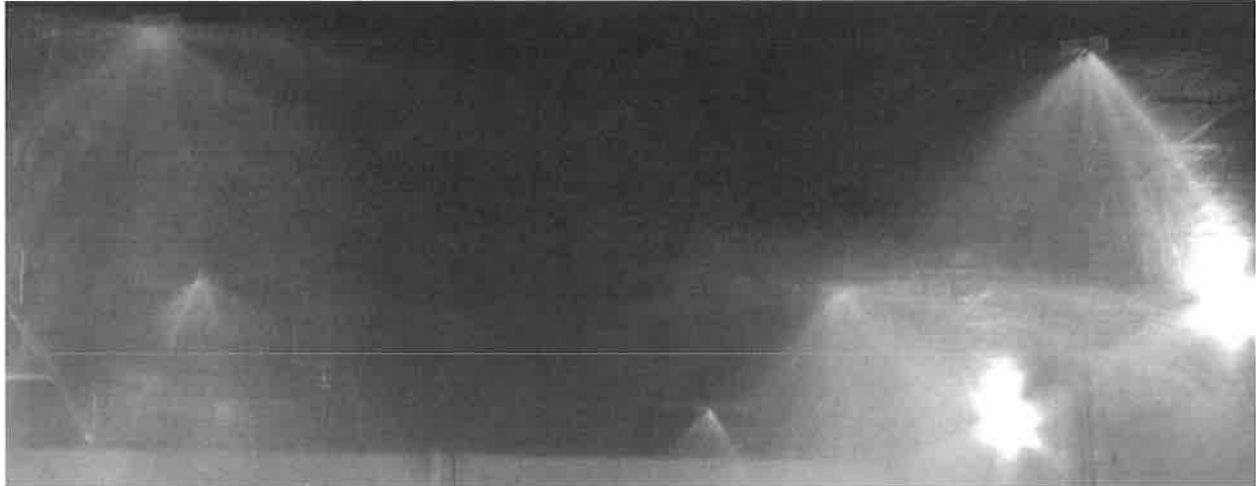
2013 KT Automatic Sprinkler 6 Sprinkler Distribution with Simulated Lodgment

This test is not typically conducted as part of the testing to the standard listed in Section 1.3 however, given the high lodgment rate determined in the hang-up test, it was deemed prudent to determine the effect of the high lodgment rate on the water distribution.

The results were deemed not to meet the requirements of the standard listed in Section 1.3.
