Evaluation of Non-Certified ESFR Sprinkler Samples

Technical Report by UL LLC

International Fire Sprinkler Association

Issued January 29, 2015

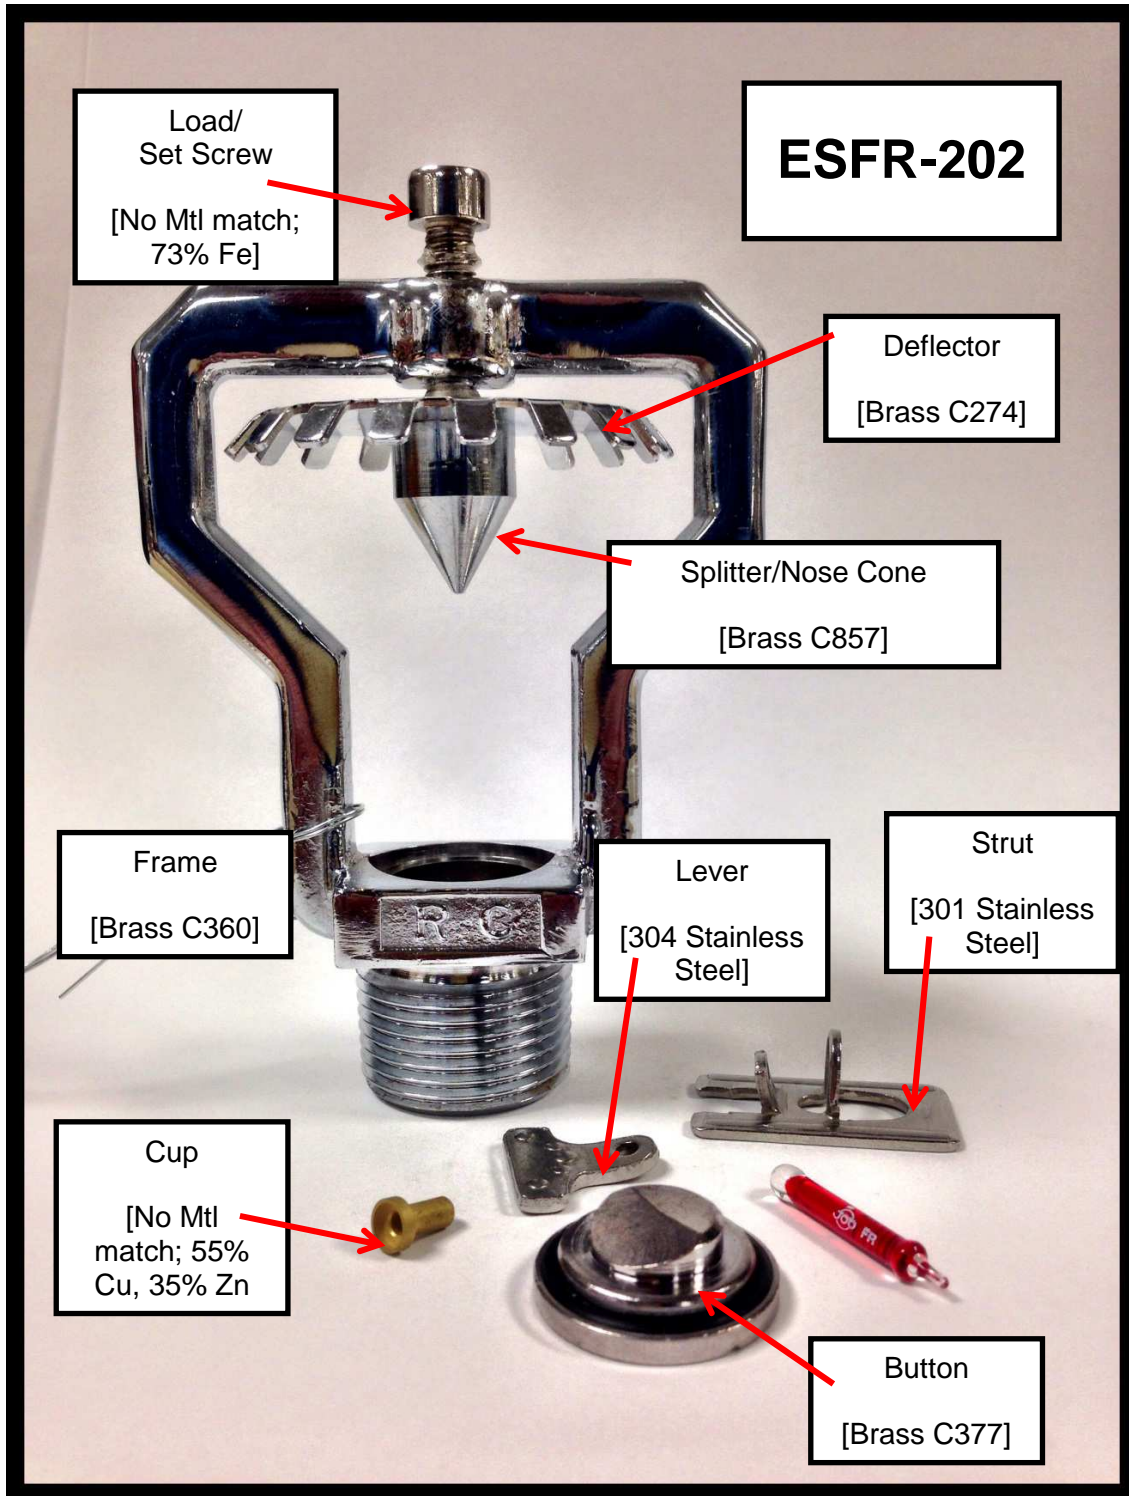
Figure 1 Model ESFR-202, Material Analysis

The closest material match for each sprinkler part is referenced in Figure 1 and Figure 2.

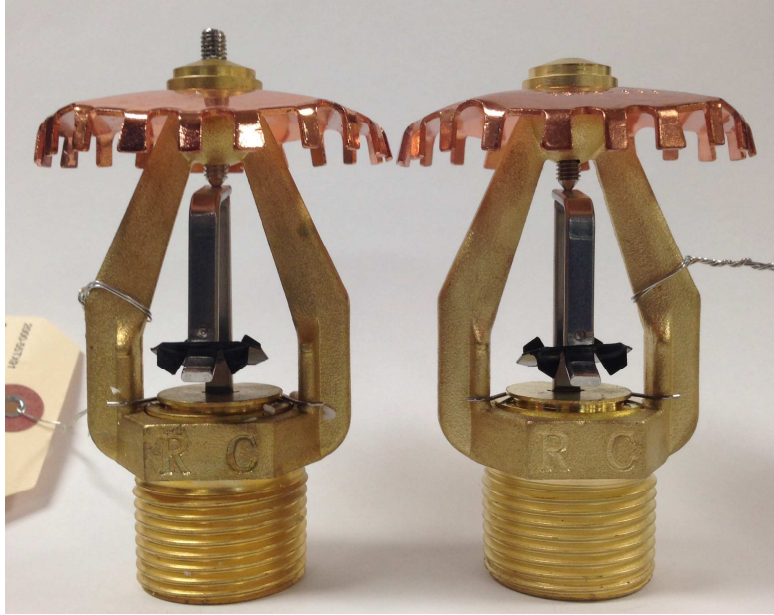
Figure 3 Model ESFR-363 Construction Inconsistencies – Load Screw

The Model ESFR-363 sprinkler samples appeared to be constructed in a similar manner, with the exception of the loading screw lengths. See Figure 3 for an example of the varying difference in length amongst.

During the examination and testing of sprinkler components, it was observed that the loading screw for both sprinkler constructions were removed with relative ease which indicated that they were insufficiently staked to maintain the factory applied load.

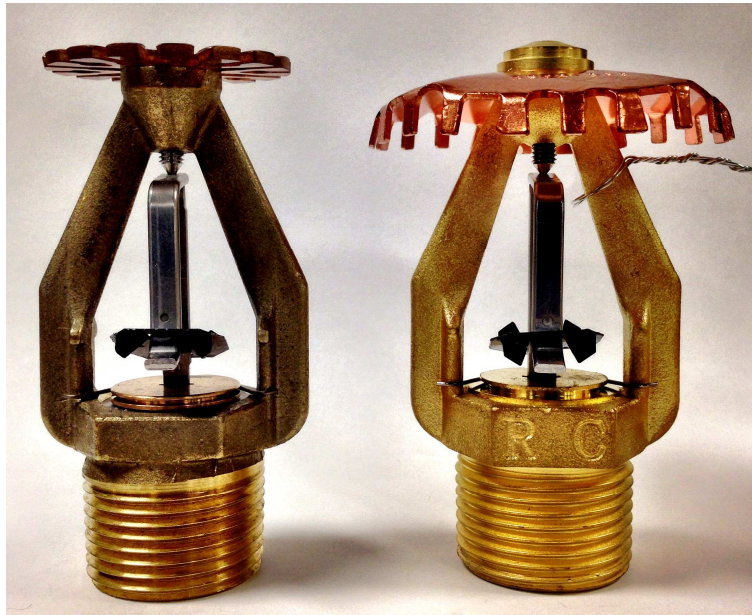
Figure 4 UL Certified ESFR sprinkler (left) vs. ESFR-363 (right) – Deflector

The ESFR-363 sprinkler utilized a deflector construction intended for use on an Extended Coverage Storage sprinkler, not an ESFR sprinkler as marked. See Figure 4 for a visual comparison of a UL certified ESFR sprinkler vs. the submitted ESFR-363.

3. **Water Deflector Constructed Similar to a Deflector Used for an Extended Coverage Sprinkler Rather Than an ESFR Sprinkler** – The upright ESFR sprinkler having a nominal discharge coefficient of $K=363 \text{ L/min}/(\text{bar}^{0.5})$ (25.2 gpm/psig^{0.5}) was visually observed to be constructed in a manner similar to a currently UL certified extended coverage storage sprinkler having a nominal discharge coefficient of $K=363 \text{ L/min}/(\text{bar}^{0.5})$ (25.2 gpm/psig^{0.5}). The water distribution pattern for an extended coverage sprinkler is significantly different compared to an ESFR sprinkler. Furthermore, the design criteria described in NFPA 13-2013 for extended coverage sprinklers for storage protection are substantially different from ESFR sprinkler system design criteria.

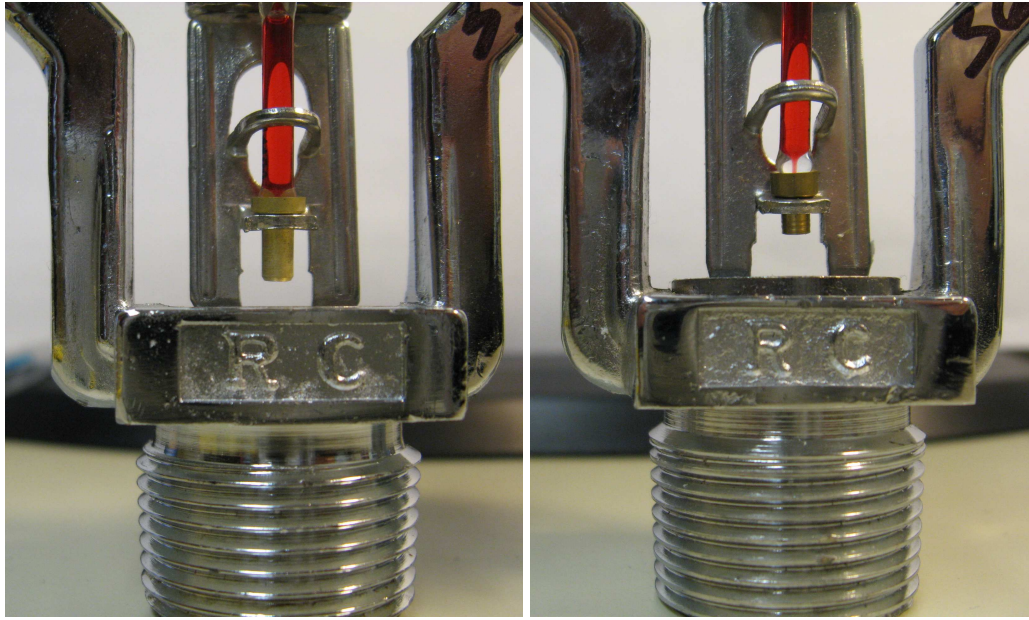
Figure 5 ESFR-202, Construction Inconsistencies – Cup

The Model ESFR-202 sprinkler samples appeared to be constructed in a similar manner, with the exception of the loading screw lengths (similar to that shown in Figure 3) and two different cup constructions (See Figure 5).

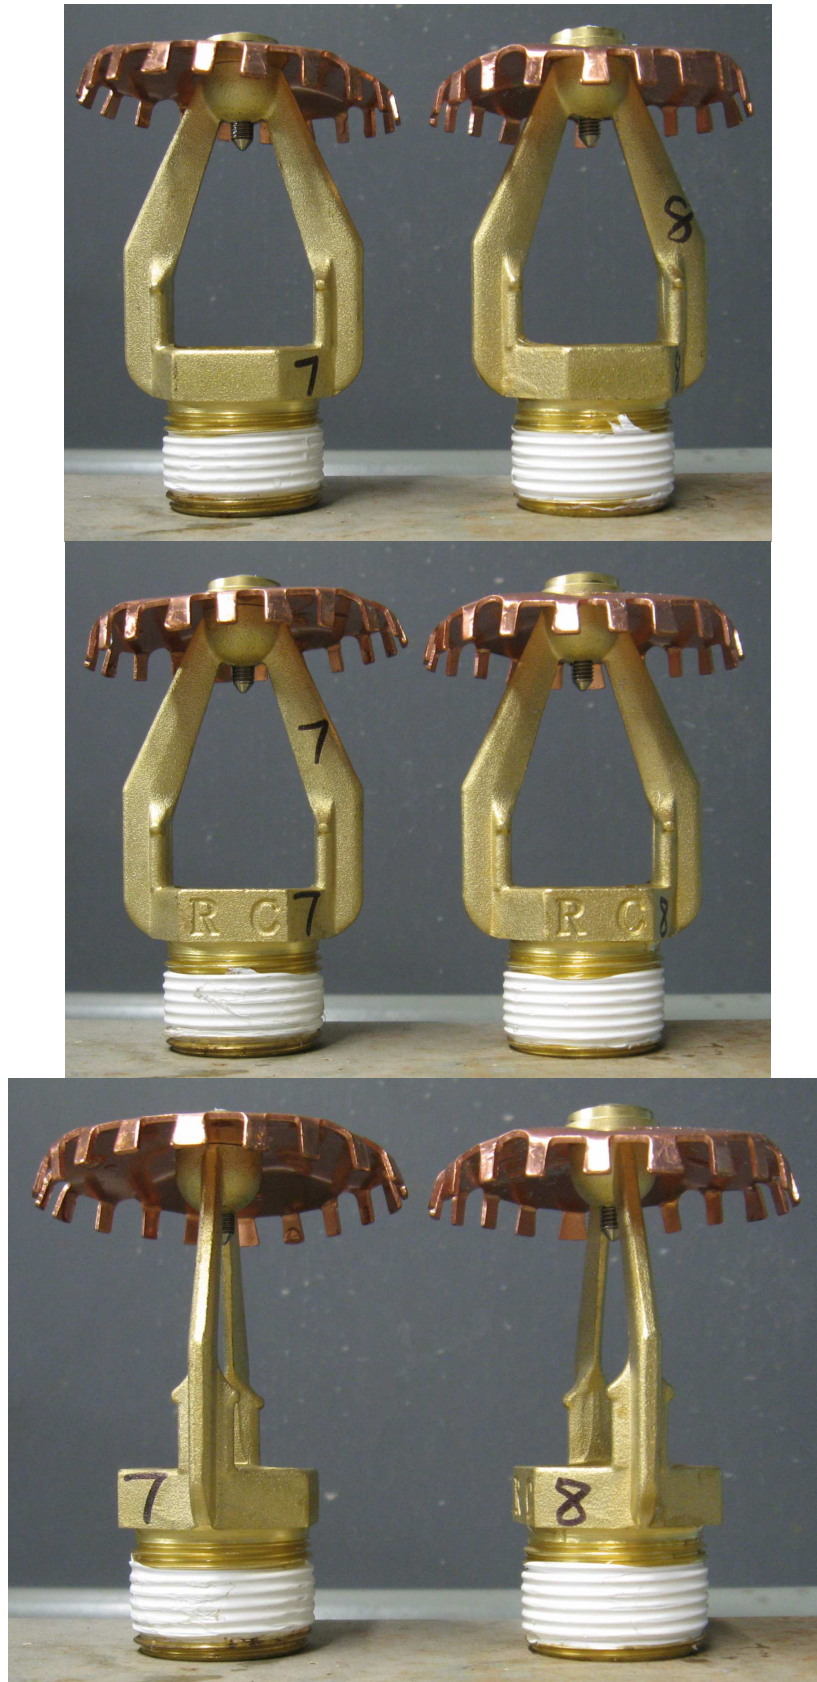
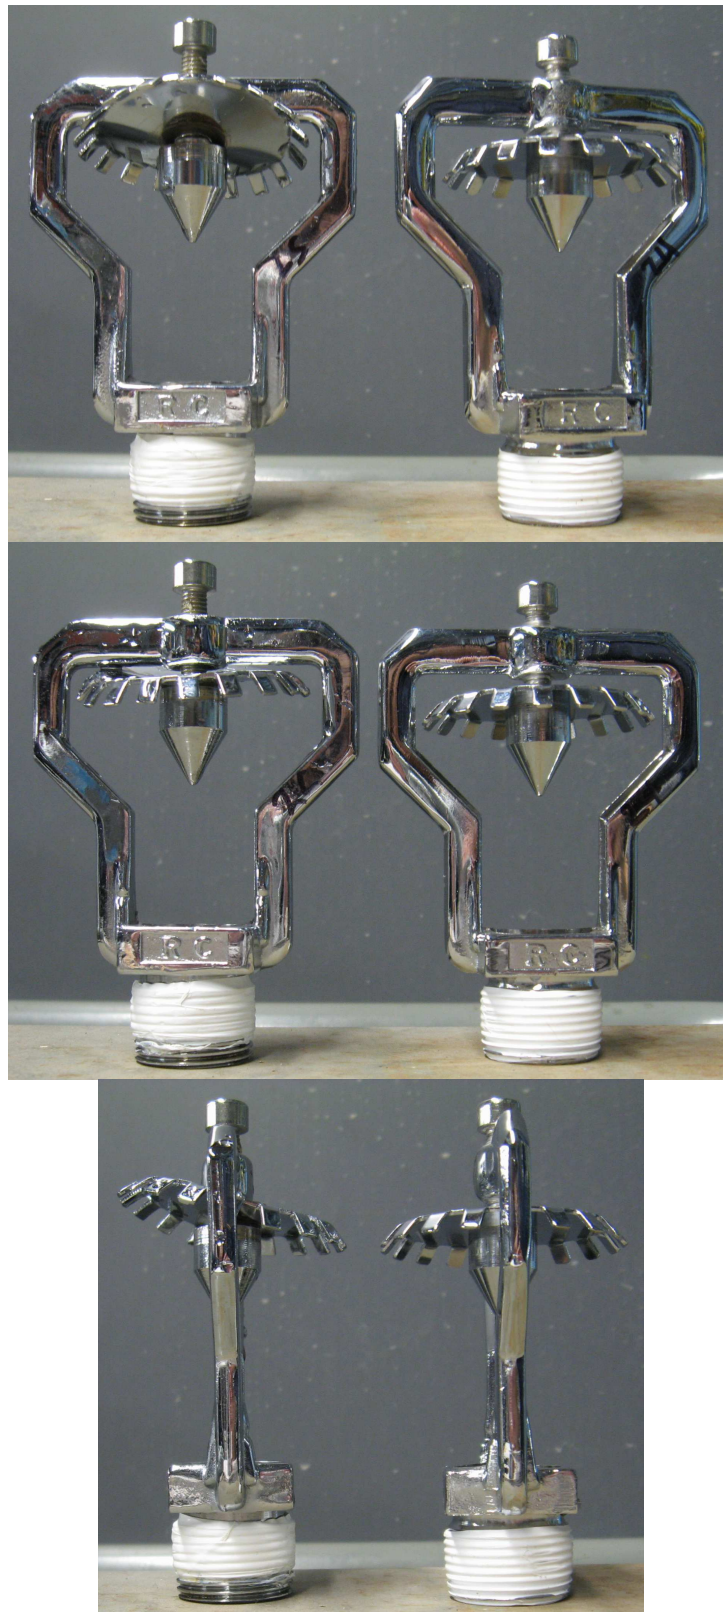
Both sprinkler models showed substantial visual deformation as illustrated in the following photos designated as Figure 6 and Figure 7. This deformation significantly altered the distribution characteristics of each sprinkler model.

Note: For comparison purposes, the sprinkler shown on the left side of the photo was subjected to the Flow Endurance Test, while the sprinkler on the right was not.

Figure 6 ESFR-363, Post-Flow Endurance Test – Deflector Deformation

Figure 7 ESFR-202, Post-Flow Endurance Test – Deflector Deformation

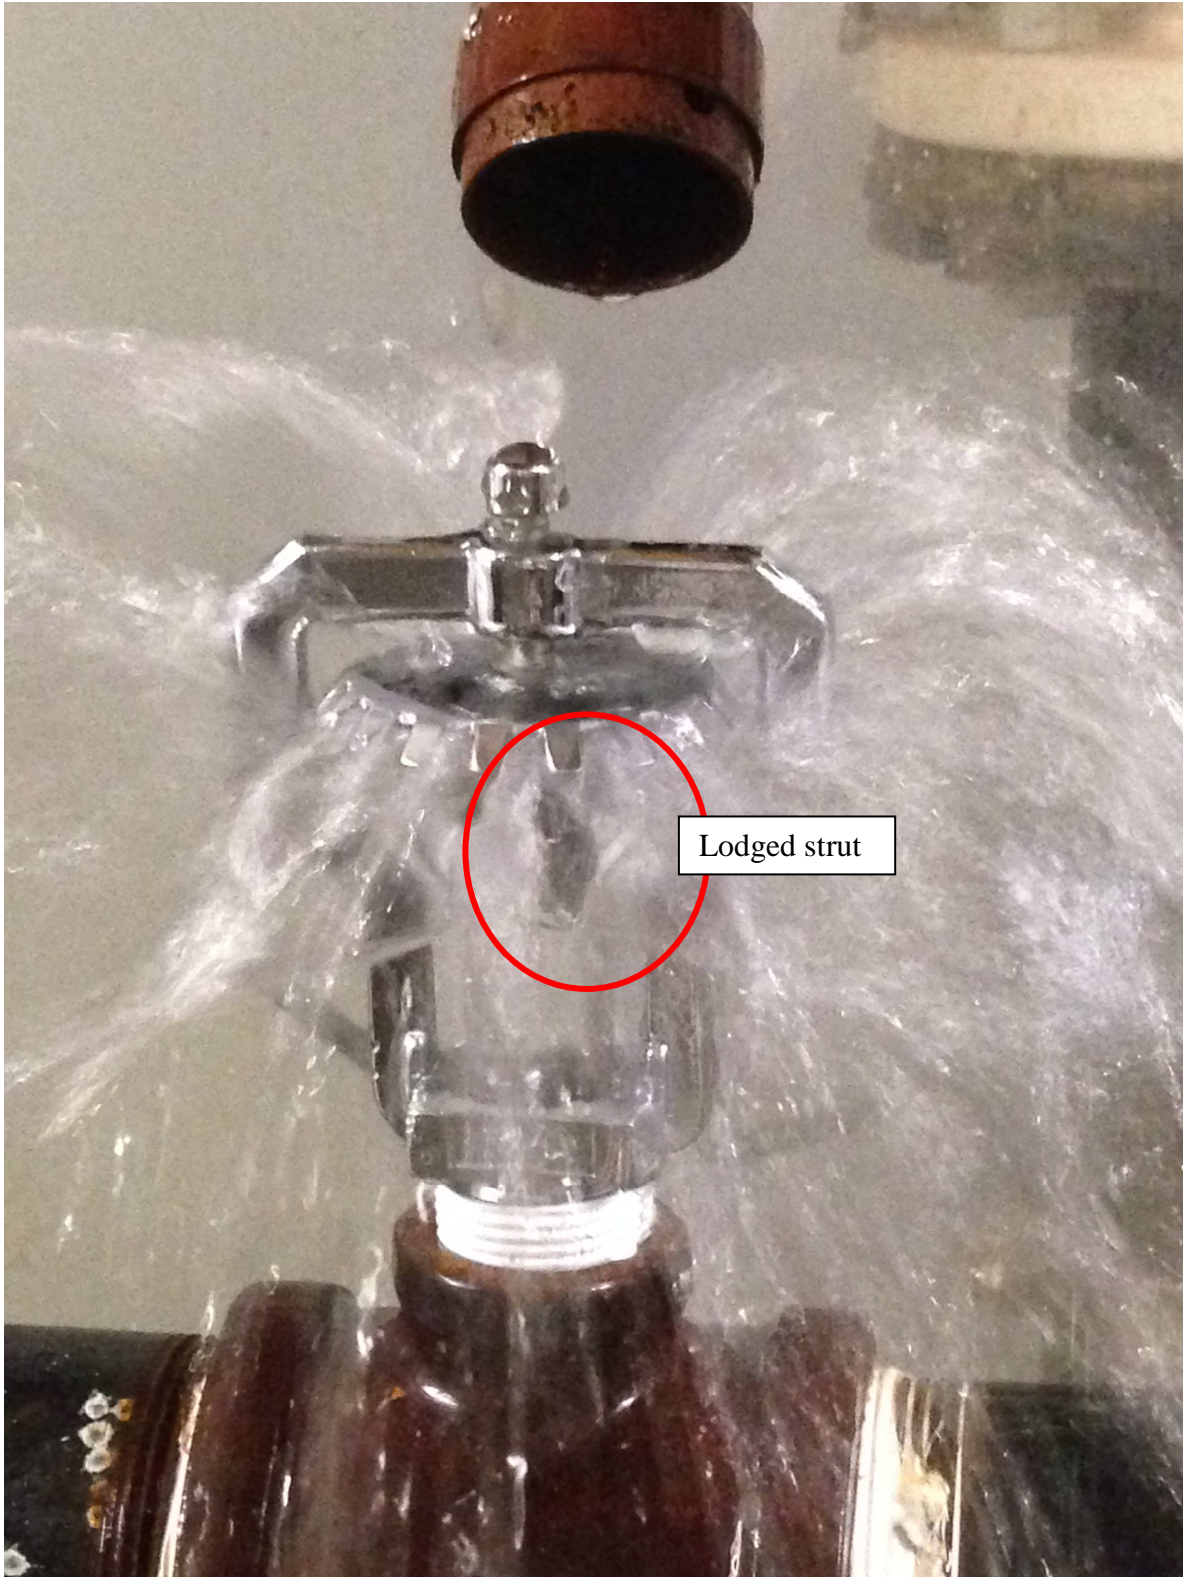
Figure 8 ESFR-202, Non-compliant Lodgment Test

Sample No.	Sprinkler Identification	Type of Water Supply Feed	Inlet Pressure, bar (psig)	Comments
5	ESFR-363	Single	1.7 (25)	Operated as intended
6		Double	1.7 (25)	Did not operate
7*		Single	3.4 (50)	Operated as intended
8*		Double	3.4 (50)	
9*		Single	5.2 (75)	
10*		Double	5.2 (75)	
11*		Single	6.9 (100)	Testing discontinued due to inability to operate some of the sprinklers even when a propane torch was directed to the sprinkler's heat responsive element
25	ESFR-202	Single	1.7 (25)	Operated as intended
26		Single	3.4 (50)	The strut lodged on/against the splitter [See Figure 8], negatively impacting the water discharge pattern by causing a large quantity of water to be discharged above the deflector, as depicted in Figure 9.
27		Double	3.4 (50)	
28		Single	5.2 (75)	
29		Double	5.2 (75)	
30		Single	6.9 (100)	
31		Double	6.9 (100)	
32		Single	8.6(125)	
33		Double	8.6 (125)

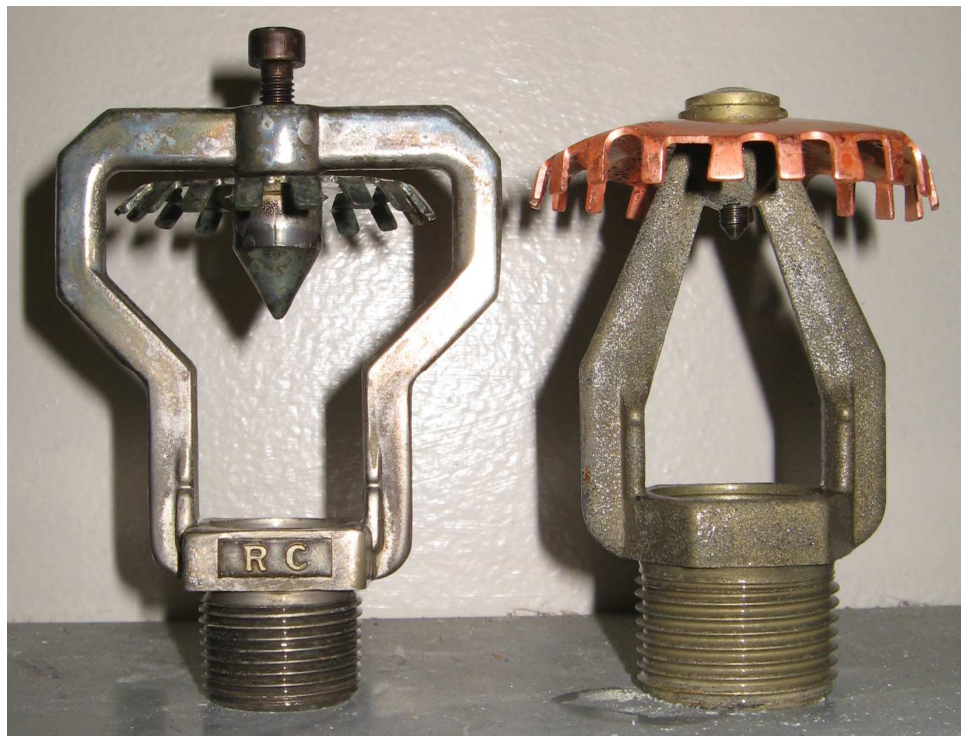
Figure 11 ESFR-202 & ESFR-363 – Post-Heat Resistance Test

The samples withstood the exposure to the heat and subsequent water immersion without significant deformation, blistering, cracking or other damage which would impair its discharge characteristics. See Figure 11 for post-exposure photo of each tested sample.

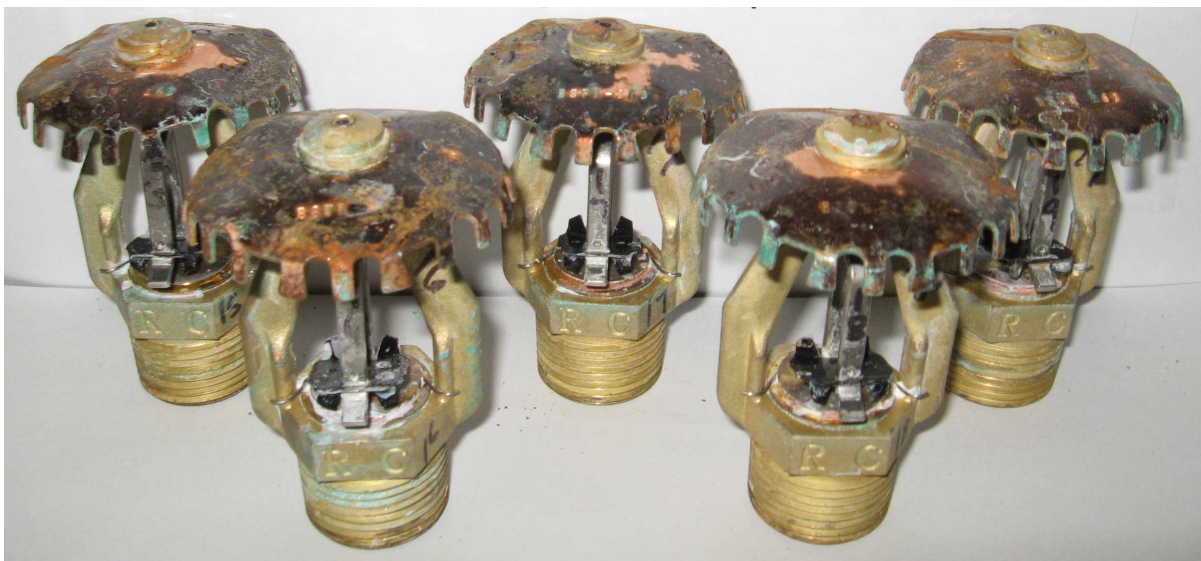
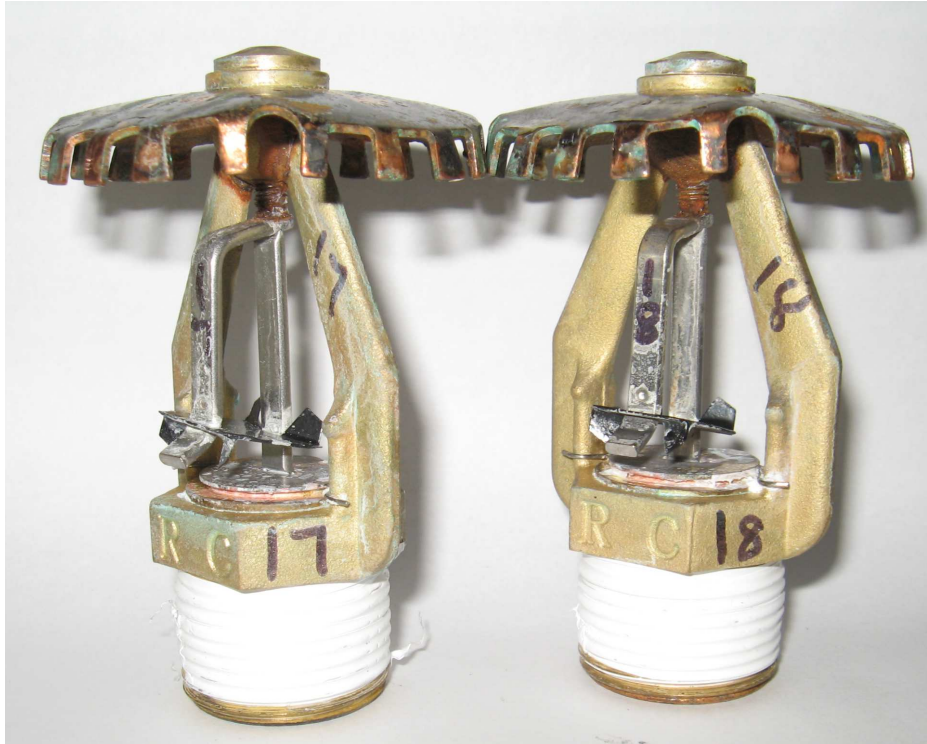
The Sensitivity Test results are presented in Table 4. See Figure 12 for a post-exposure photo of the sprinklers prior to Sprinkler Sensitivity testing. See Figure 13 for photos of the two sprinklers that did not operate after being subjected to the Sensitivity Test.

Sample No.	Sprinkler Identification	Temperature Rating, °C (°F)	Element Position	Operating Time, s	RTI, (m-sec) ^{1/2}	Maximum RTI Permitted in UL 1767
15	ESFR-363	74 (165)	Most Favorable	37.41	102	36
16				41.89	115	
17				DNO*	-	
18				DNO*	-	
19				73.85	202

*Did not operate within 240 seconds at which point the test was terminated.

Figure 12 ESFR-363 Post-10-Day Salt Spray Exposure

Figure 13 ESFR-363 10-Day Corrosion Samples, Post-Sensitivity Test

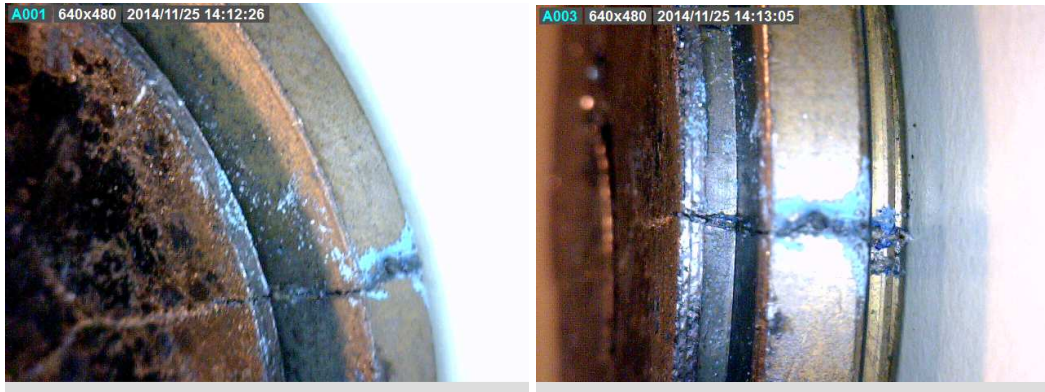
Figure 14 ESFR-363 Button – Images of Post-Stress Corrosion Cracking of Brass Parts Test

Sample No.	Sprinkler Identification	Brass Component Tested	Comments
3	ESFR-363	Frame	No cracking was observed.
		Screw Cap	No cracking was observed.
		Button	Cracking observed. See Figure 14 for 25x magnified image confirming cracking.
23	ESFR-202	Cup	No cracking was observed.

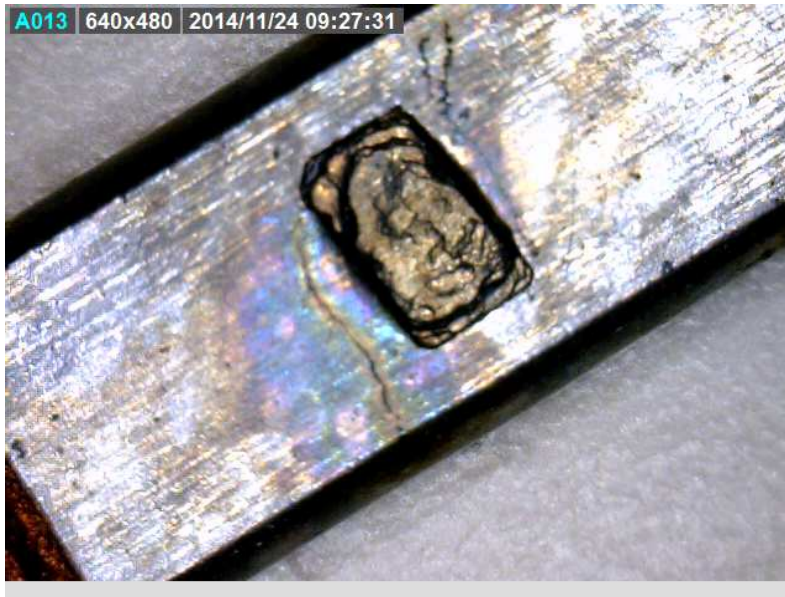
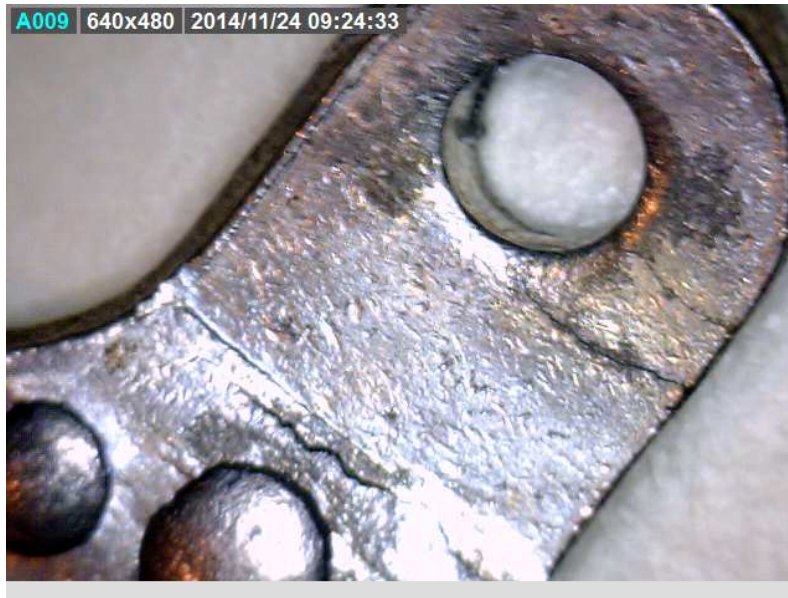
Sample No.	Sprinkler Identification	Stainless Steel Component Tested	Comments
3	ESFR-363	Strut	Cracking observed. See Figure 15 for 25x magnified image confirming cracking.
		Lever	No cracking was observed.
		Wire Spring	No cracking was observed.
23	ESFR-202	Strut	No cracking was observed.
		Lever	Cracking observed. See Figure 16 for 25x magnified image confirming cracking.

Figure 15 ESFR-363 Strut – Images of Post-Stress Corrosion Cracking of Stainless Steel Parts Test

Figure 16 ESFR-202 Lever – Images of Post-Stress Corrosion Cracking of Stainless Steel Parts Test
