**Evaluation of Model ZSTX-15 SSP and ZSTZ-15 SSU
Non-Certified Sprinkler Samples**

Technical Report by UL LLC

International Fire Sprinkler Association

Issued: June 10, 2016

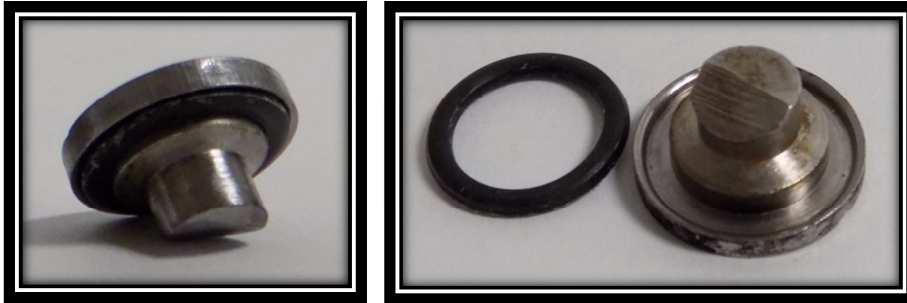
Figure 3 O-ring Seal

Both the Models ZSTX-15 pendent and ZSTZ-15 sprinklers utilized a dynamic O-ring type water seal, as shown in Figure 3, which has not been permitted in ANSI/UL 199 since January 9, 2003.

1. **O-ring Water Seals** – Both sprinkler constructions utilized an O-ring style water seal assembly. O-rings have not been permitted in UL certified sprinkler constructions since January 9, 2003 due to the potential for this type of water seal construction to leak or not permit the discharge of water from a sprinkler after exposure to field installation environments. Previous UL research indicated that elastomeric O-ring water seals used in sprinklers have the potential to adhere to the mating surface and are susceptible to the collection of corrosion and other products in the small annular spaces between the operating parts causing inhibited sprinkler operation. The following link provides an example of a product recall issued on O-ring sealed sprinklers: <http://www.cpsc.gov/en/recalls/2001/cpsc-central-sprinkler-company-announce-voluntary-recall-to-replace-o-ring-fire-sprinklers/>

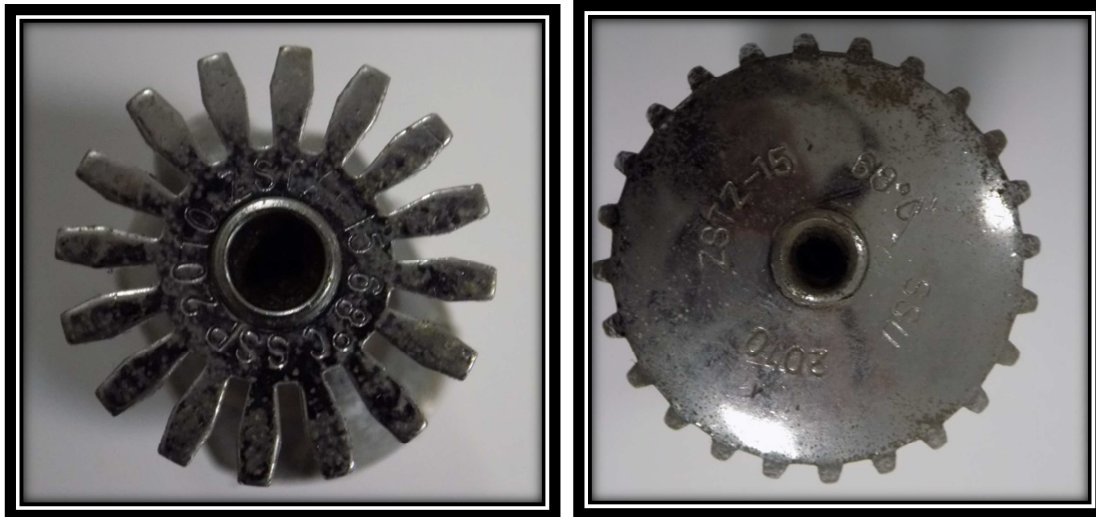
Figure 5 Deflector Markings

The pendent sprinkler construction was marked “ZSTX-15 68°C SSP 2010,” suggesting the sprinkler. The upright sprinkler construction was marked “ZSTZ-15 68°C SSU 2010”. In addition, the wrench boss of both the pendent and upright constructions were marked with “P A” on one side. See Figure 5 and Figure 6 for all markings.

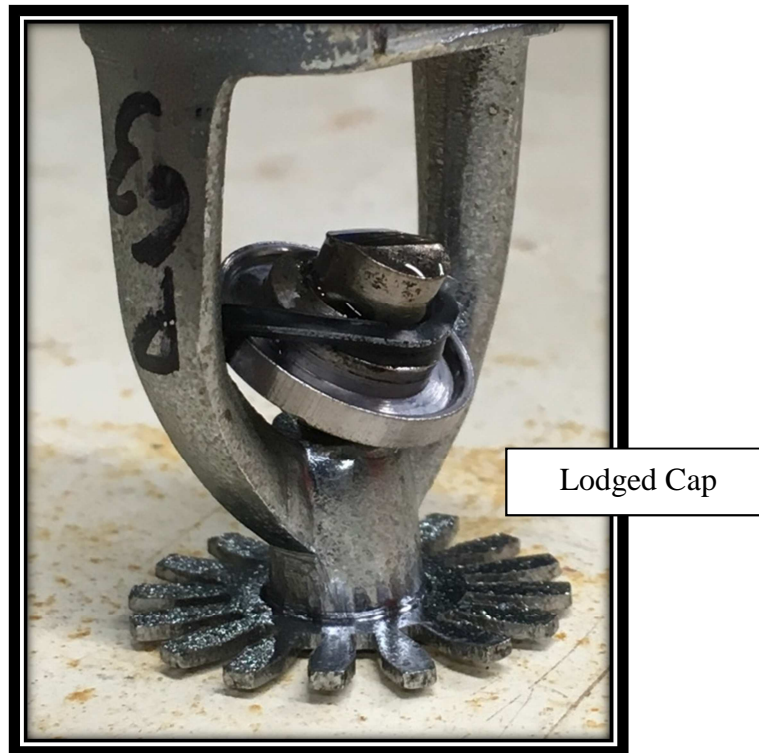
Figure 10 Sample P63 – Double Feed Pendent, Non-compliant Lodgment Test

Sample Nos.	Sprinkler Identification	Inlet Pressure, bar (psig)	Comments
P40-P44	ZSTX-15	1.7 (25)	Operated as intended
P45-P49	ZSTX-15	3.4 (50)	Operated as intended
P50-P54	ZSTX-15	5.2 (75)	Operated as intended
P55-P59	ZSTX-15	6.9 (100)	Operated as intended
P60-P61	ZSTX-15	8.6 (125)	Operated as intended
P62			The cap lodged on the frame arm, adversely impacting the water discharge pattern
P63			The cap lodged on the set screw, adversely impacting the water discharge pattern [See Figure 10]
P64			Operated as intended
P65-P69	ZSTX-15	10.3 (150)	Operated as intended
P70	ZSTX-15	12.1 (175)	The cap lodged on the set screw, adversely impacting the water discharge pattern
P71			Operated as intended
P72			The cap lodged on the set screw, adversely impacting the water discharge pattern
P73			Operated as intended
P74			Operated as intended
U61	ZSTX-15	0.5 (7)	Operated as intended
U62			DNO [See Figure 11]
U63-U65			Operated as intended

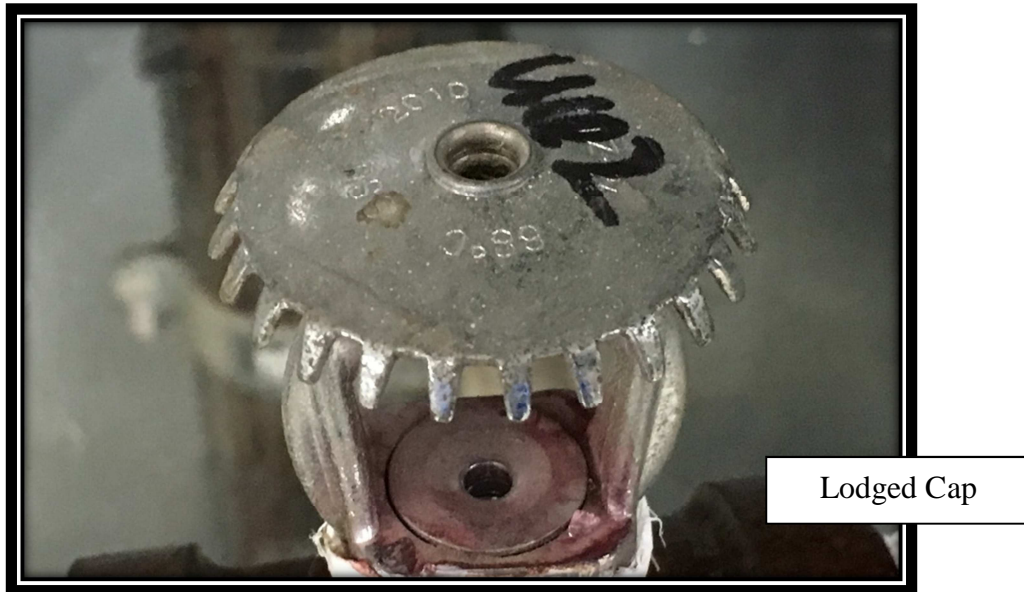
Figure 11 Sample U62 – Double Feed Upright, Non-compliant Lodgment Test

DNO – Glass bulb operated, but the water seal did not release with the applied water pressure of 0.5 bar (7 psig). Subsequently, the sprinkler was subjected to a gradually increasing water inlet pressure to determine the pressure required to release the water seal. For sample U62, this pressure was 2.14 bar (31 psig).

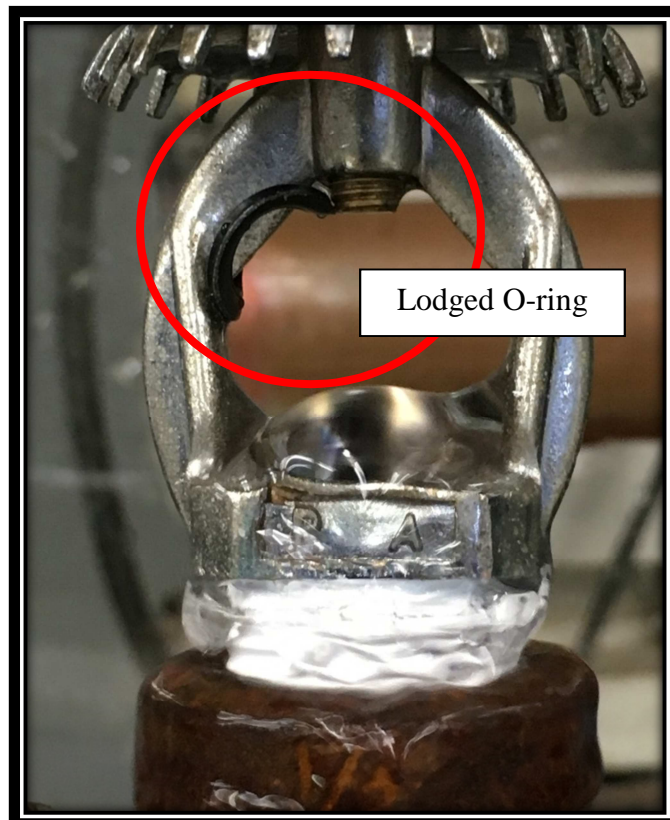
Figure 12 Sample U74 – Double Feed Upright, Non-compliant Lodgment Test

U66-U70	ZSTX-15	1.7 (25)	Operated as intended
U71-U73	ZSTX-15	3.4 (50)	Operated as intended
U74			The O-ring separated from the cap and lodged on the frame arm, adversely impacting the water discharge pattern [See Figure 12]
U75			Operated as intended
U76-U80	ZSTX-15	5.2 (75)	Operated as intended
U81-U83	ZSTX-15	6.9 (100)	Operated as intended
U84			The cap lodged on the set screw, adversely impacting the water discharge pattern
U85			Operated as intended
U86-U88	ZSTX-15	8.6 (125)	Operated as intended
U89			The cap lodged on the set screw, adversely impacting the water discharge pattern [See Figure 13 for post-test image of cap and O-ring after water exposure ended]
U90			Operated as intended
U91-U95	ZSTX-15	10.3 (150)	Operated as intended
U96-U97	ZSTX-15	12.1 (175)	Operated as intended
U98	ZSTX-15	12.1 (175)	The cap lodged on the set screw, negatively impacting the water discharge pattern [See Figure 14 for post-test image of cap and O-ring after water exposure ended]

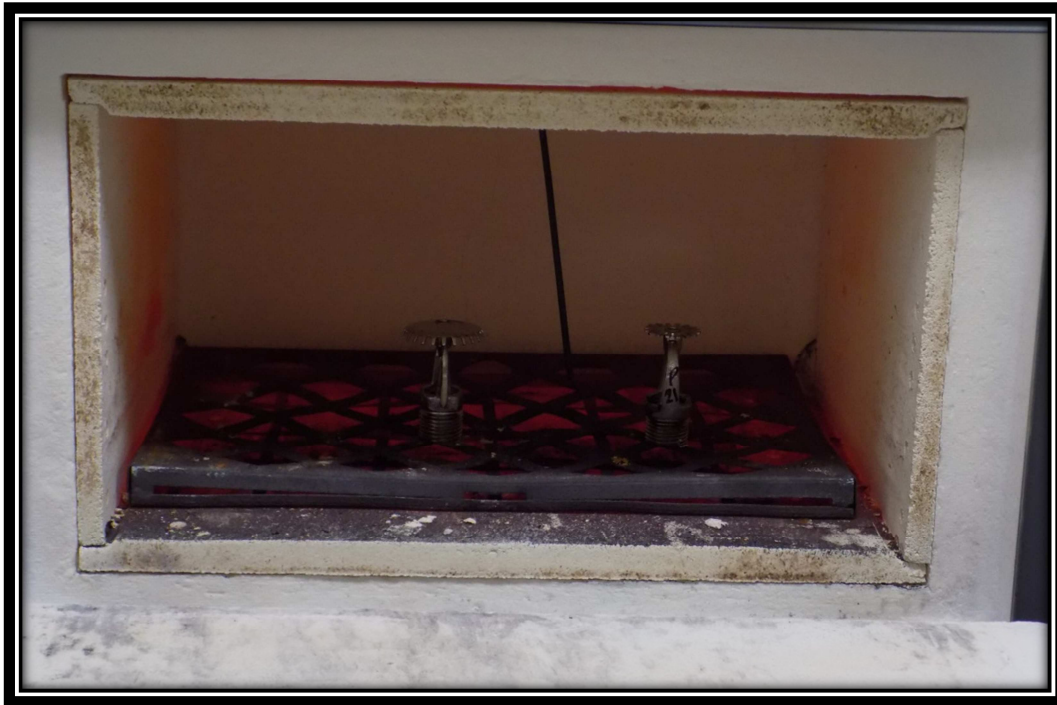
Figure 15 Heat Resistance Samples – Test Set Up

Two samples of each of the Model ZSTX-15 pendent and ZSTZ-15 upright sprinklers, without operating parts, were placed vertically on their inlet in an oven heated to $650 \pm 10^{\circ}\text{C}$ ($1200 \pm 20^{\circ}\text{F}$) for 15 minutes, as shown in Figure 15. Following this exposure, each sample was removed from the oven and immediately submersed in a water bath having a temperature of $15 \pm 6^{\circ}\text{C}$ ($60 \pm 10^{\circ}\text{F}$). The samples were then examined for signs of fracture, deformation, or other damage, as specified in ANSI/UL 199.

The samples withstood the exposure to the heat and subsequent water immersion without significant deformation, blistering, cracking or other damage which would impair its discharge characteristics.
