TEST REPORT

Project No: 3058840

Class: Class Series 2000, Class 2017, Automatic Sprinklers, Non-Storage, Pendent

Product Name: Model 2013 KT, 2014 SHKT and 2015 SHKT with a Nominal Discharge Coefficient of 5.6 gal/min/(psi)^{1/2} [80.7 L/min/bar^{1/2}] in Chrome Finish, with a Nominal Temperature Rating of 155°F (68°C) (F5 Job Bulbs)

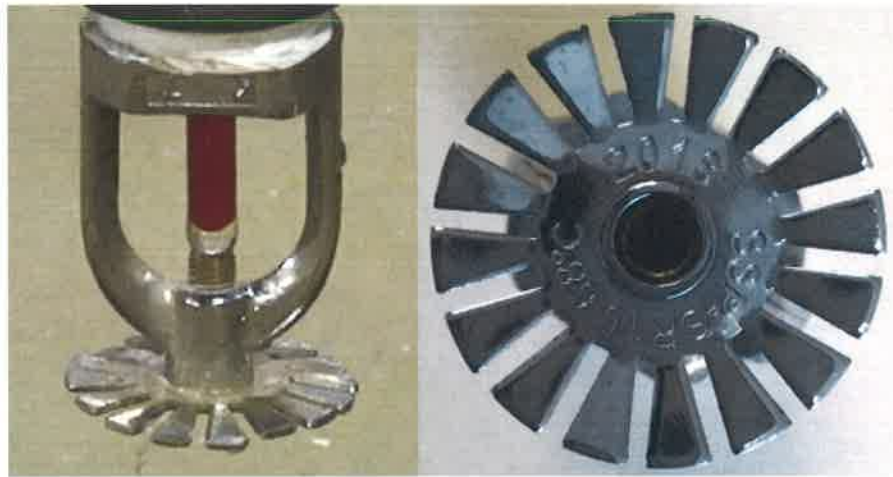
2013 KT Automatic Sprinkler

Eighty samples (“2013 KT”) total were installed in their intended orientation on a water supply line. Five samples at each water pressure of 7, 25, 50, 75, 100, 125, 150 and 175 psi (0.5, 1.7, 3.4, 5.2, 6.9, 8.6, 10.3 and 12.1 bar) were tested utilizing a double feed piping arrangement. Five samples at each water pressure of 7, 25, 50, 75, 100, 125, 150 and 175 psi (0.5, 1.7, 3.4, 5.2, 6.9, 8.6, 10.3 and 12.1 bar) were tested utilizing a single feed piping arrangement. The samples were each activated using a suitable heat source and observed. The results are shown in Table 1. The cumulative lodgment rate for the forty samples tested in the double feed piping configuration was 47.5% (19/40). The cumulative lodgment rate for the forty samples tested in the single feed piping configuration was 37.5% (15/40). The cumulative lodgment rate for all eighty samples tested was 42.5% (34/80). In order to fulfill the requirements of the standard listed in Section 1.3, the cumulative lodgment rate cannot exceed 1%. It should be noted that the cumulative lodgment rate at 150 psi [10.3 bar] was 80% (8/10) with 100% of the samples tested on the double pipe configuration at 150 psi [10.3 bar] resulting in a lodgment. Similarly, the cumulative lodgment rate at 175 psi [12.1 bar] was 80% (8/10) with 100% of the samples tested on the single pipe configuration at 175 psi [12.1 bar] resulting in a lodgment.

Model	Pressure (psi)	Feed Direction	Number of Samples Tested	Number of Failures	Failure Rate (%)
KT	7	double	5	1	20
KT	25	double	5	1	20
KT	50	double	5	2	40
KT	75	double	5	2	40
KT	100	double	5	3	60
KT	125	double	5	2	40
KT	150	double	5	5	100
KT	175	double	5	3	60
KT	7	single	5	1	20
KT	25	single	5	0	0
KT	50	single	5	0	0
KT	75	single	5	1	20
KT	100	single	5	4	80
KT	125	single	5	1	20
KT	150	single	5	3	60
KT	175	single	5	5	100

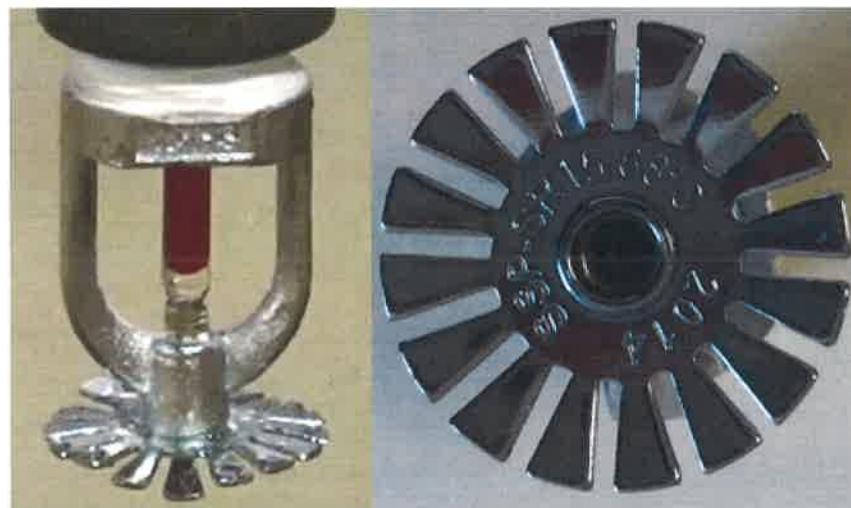
2014 SHKT Automatic Sprinkler

Fifteen samples total ("2014 SHKT") were installed in their intended orientation on a water supply line. Five samples at each water pressure of 7, 75 and 175 psi (0.5, 5.2 and 12.1 bar) were tested utilizing a double feed piping arrangement. The samples were each activated using a suitable heat source and observed. The results are shown in Table 2. The cumulative lodgment rate for the samples was 46.7% (7/15). In order to fulfill the requirements of the standard listed in Section 1.3, the cumulative lodgment rate cannot exceed 1%. It should be noted that the lodgment rate at 175 psi [12.1 bar] was 100% (5/5).

Model	Pressure (psi)	Feed Direction	Number of Samples Tested	Number of Failures	Failure Rate (%)
SHKT	7	double	5	0	0
SHKT	75	double	5	2	40
SHKT	175	double	5	5	100

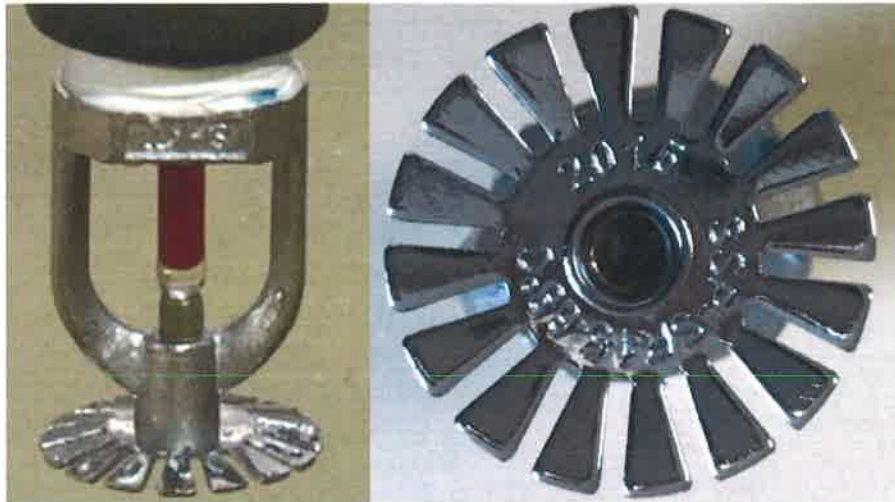
2015 SHKT Automatic Sprinkler

Five samples total (“2015 SHKT”) were installed in their intended orientation on a water supply line. Five samples at a water pressure of 175 psi (12.1 bar) were tested utilizing a double feed piping arrangement. The samples were each activated using a suitable heat source and observed. The results are shown in Table 3. The lodgment rate for the samples was 80.0% (4/5). In order to fulfill the requirements of the standard listed in Section 1.3, the cumulative lodgment rate cannot exceed 1%.

Model	Pressure (psi)	Feed Direction	Number of Samples Tested	Number of Failures	Failure Rate (%)
SHKT	175	double	5	4	80
