Evaluation of Non-Certified ESFR Sprinkler Samples

Technical Report by UL LLC

International Fire Sprinkler Association

Issued January 29, 2015

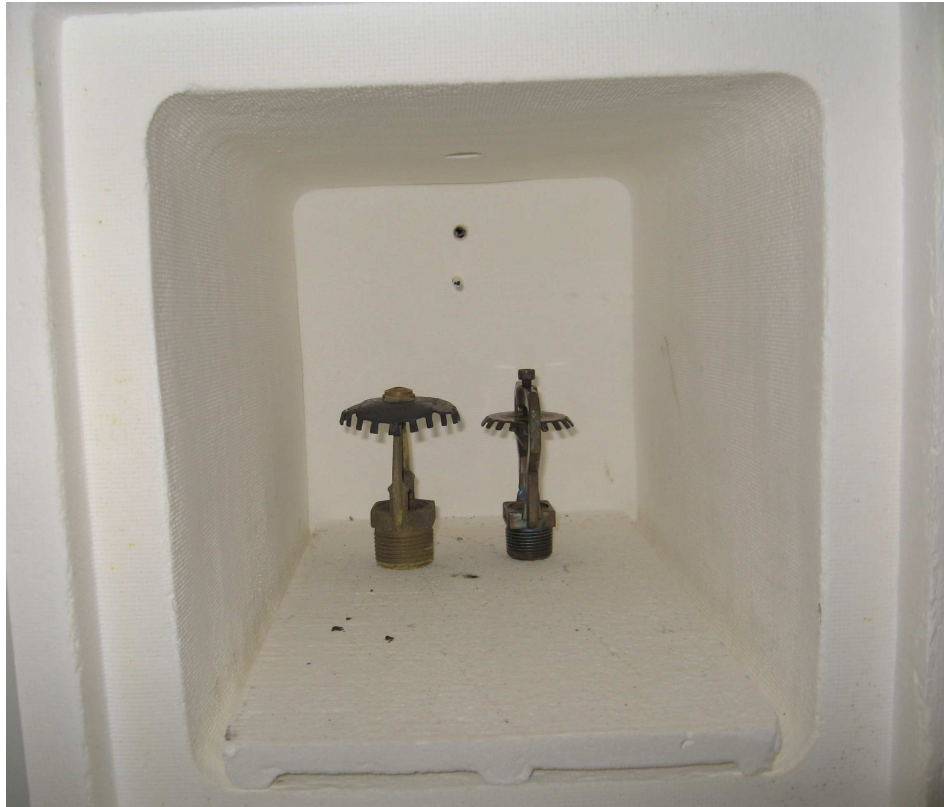
Figure 10 Heat Resistance Samples – Test Set-Up

One sample of each of the Model ESFR-363 and ESFR-202 sprinklers, without operating parts, was placed vertically on its inlet in an oven heated to $650 \pm 10^{\circ}\text{C}$ ($1200 \pm 20^{\circ}\text{F}$) for 15 minutes, as shown in Figure 10. Following this exposure, each sample was removed from the oven and immediately submerged in a water bath having a temperature of $15 \pm 6^{\circ}\text{C}$ ($60 \pm 10^{\circ}\text{F}$). The samples were then examined for signs of fracture, deformation, or other damage, as specified in ANSI/UL 1767.
